NRL Memorandum Report 6861

High Pressure Turbine Blade Life Extension

H. H. SMITH AND D. J. MICHEL

August 28, 1991

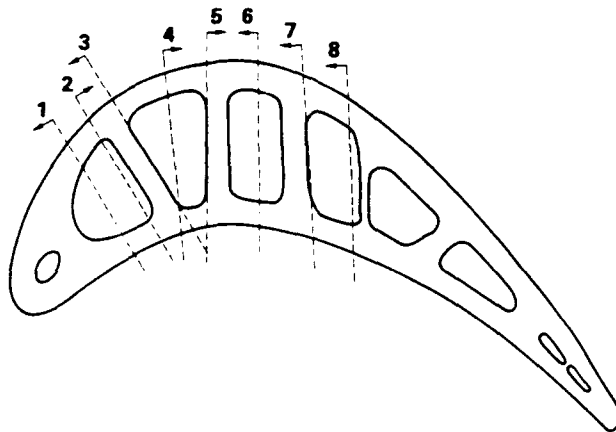
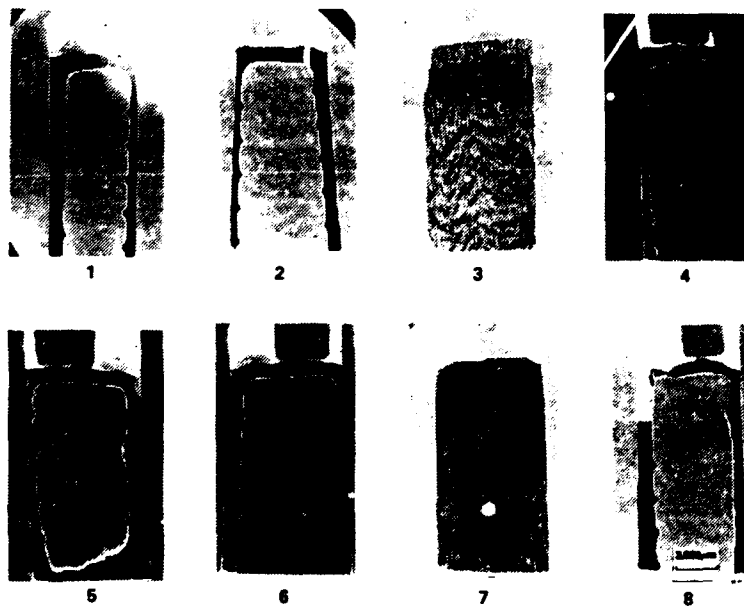
Figure 10. Section views of the microstructure of a DS-R80H blade illustrating the blade-weld interface through the blade cross-section.

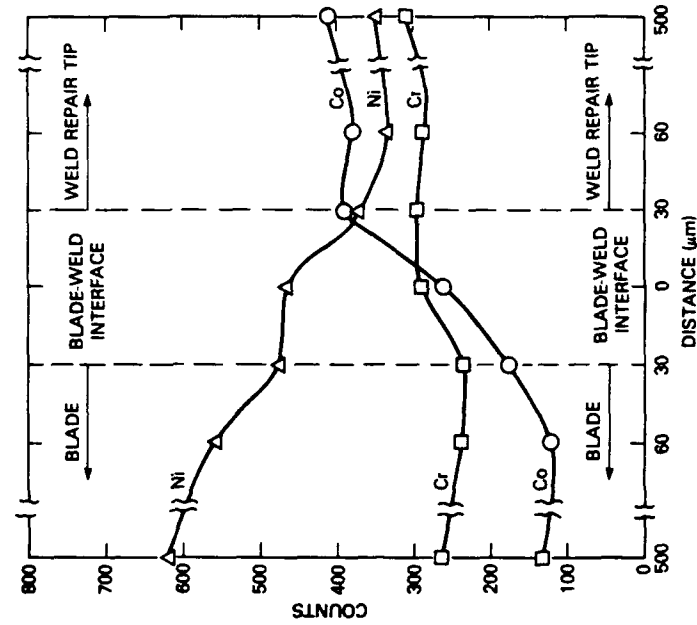
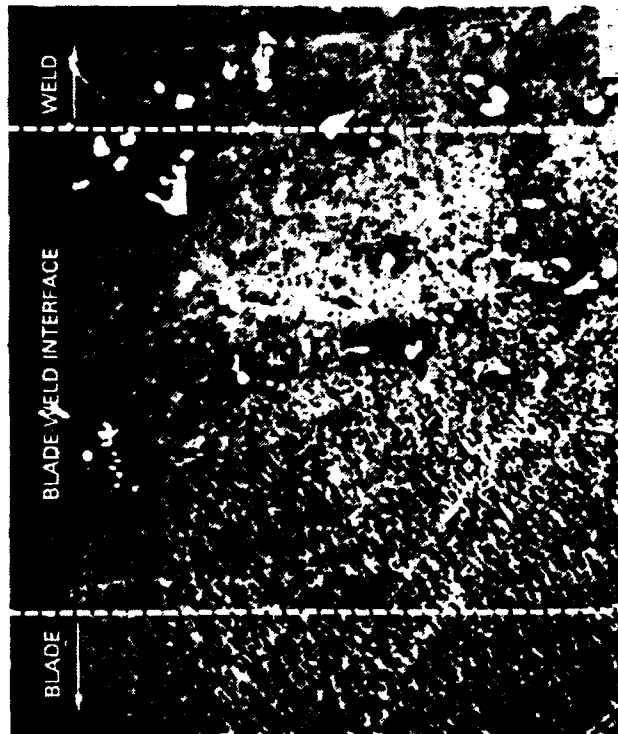
The composition profiles of nickel, chromium and cobalt through the blade-weld interface are shown in Figure 12. The profiles confirm that minimal intermixing of the blade and weld alloys occurred during the tip repair process. Additional detail of the microstructure of the blade/weld interface is illustrated by the TEM micrographs in Figure 13. The micrographs show the change in the microstructure from the blade alloy to the weld as the interface was traversed. The micrographs clearly show the minimal intermixing of the blade and weld alloys which occurred during the blade tip repair process.

Figure 12. Microstructure of the blade-weld interface region and composition profiles detailing the Co, Ni and Cr gradients through the interface.

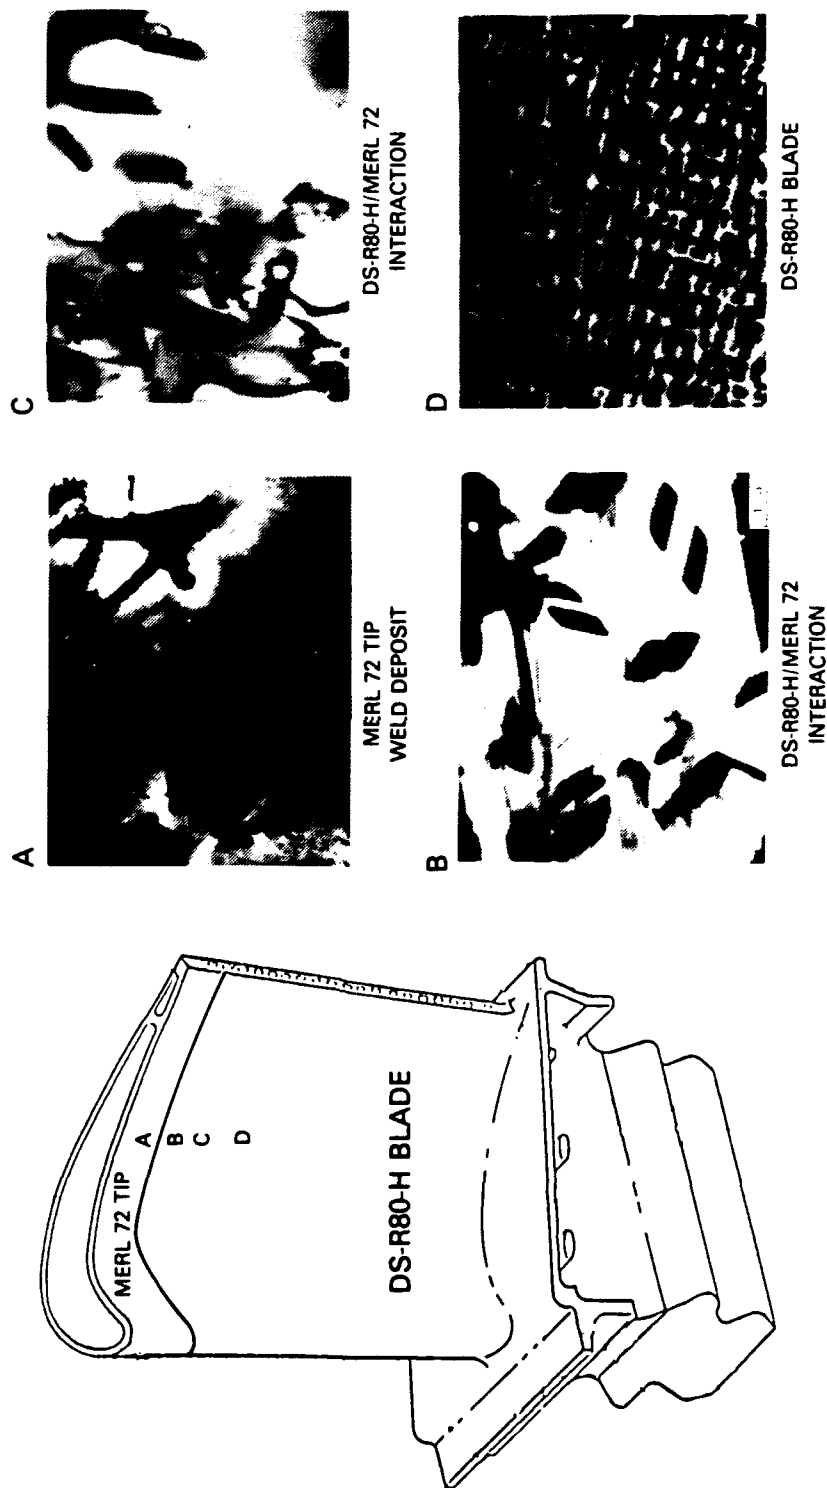
Figure 13. Transmission electron micrographs of the blade-weld interface region showing the change in the precipitate microstructure with location relative to the interface.

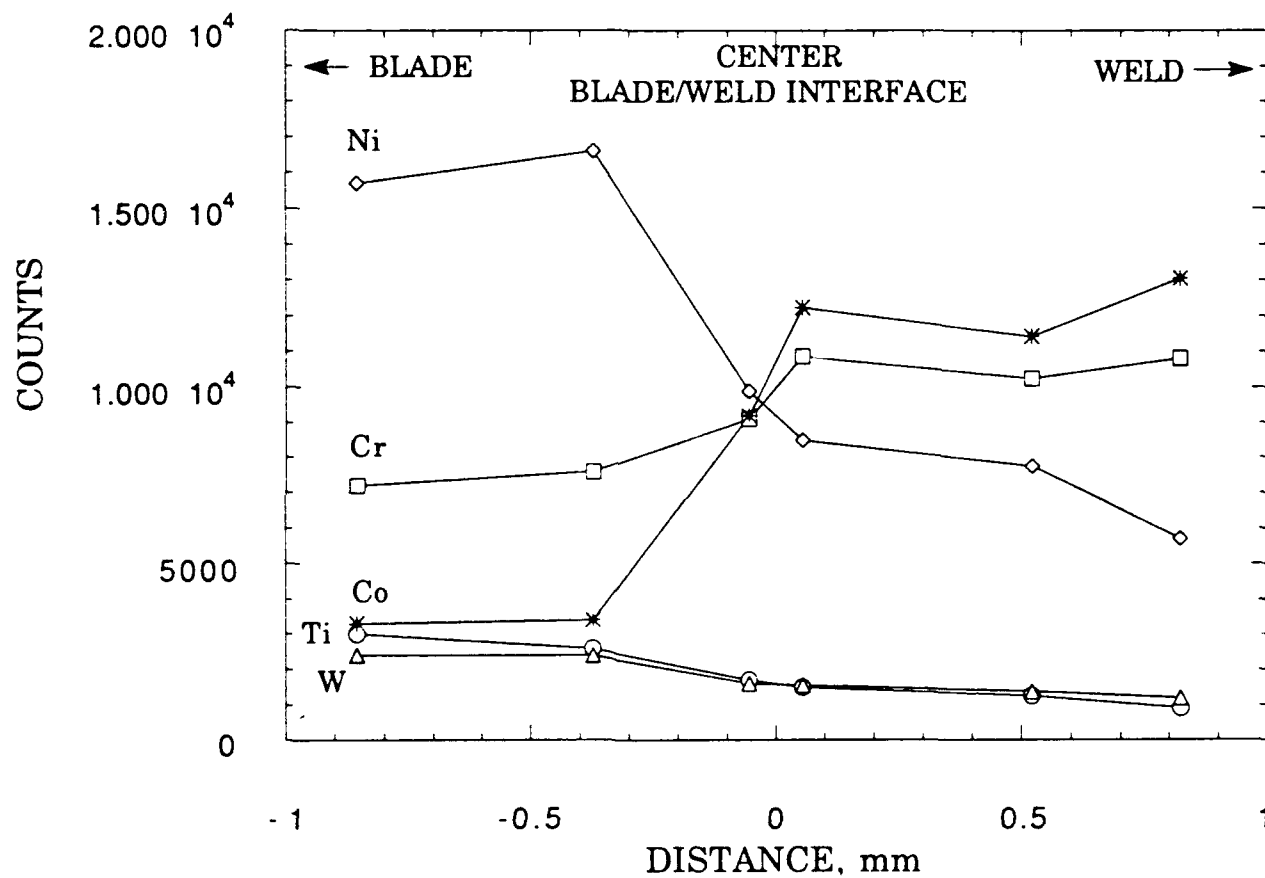
The ASMET engine tested blades showed no metallurgical weld defects, such as cracking or porosity. Weld metal dilution effects were examined using the SEM to conduct semi-quantitative energy dispersive x-ray analyses of the blade-weld interface region. Alloy composition profiles are shown in Figure 22 for the elements Ni, Cr, Co, Ti and W. The data indicate that elemental mixing at the interface of the repair was confined to a region approximately 1 mm or less in overall extent. These results are in agreement with those found for previously repaired blades, Figure 12, and suggest that the weld repair process can be expected to be repeated with considerable consistency.

Figure 22. Semi-quantitative compositional analysis of the DS-R80H blade/MERL 72 weld interface region of an ASMET engine tested blade.

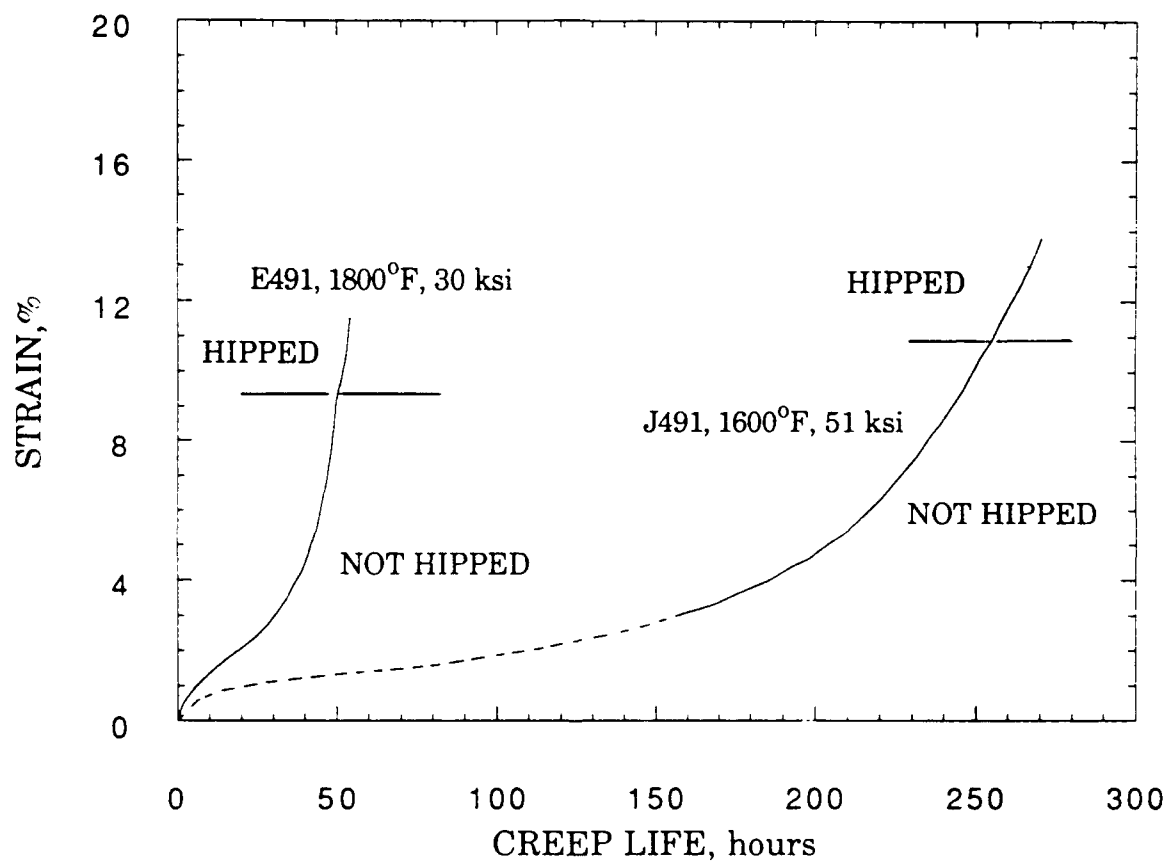
The results in Figure 25 show that the HIP processing provided little change to the creep response of the DS-R80H when compared with the results from the not-HIP processed creep specimens of material 491. As shown in Table 2, the combined not-HIP/HIP processed creep life of specimens of material 491 was slightly reduced from the life of the not-HIP processed specimens tested at both temperatures. In addition, the mid-test application of the HIP and heat treatment cycle reduced the specimen reduction in area and elongation values by approximately 50% when compared with the not-HIP processed condition.

Figure 25. Creep-rupture results for not-HIP processed DS-R80H tested at 871 and 982°C.

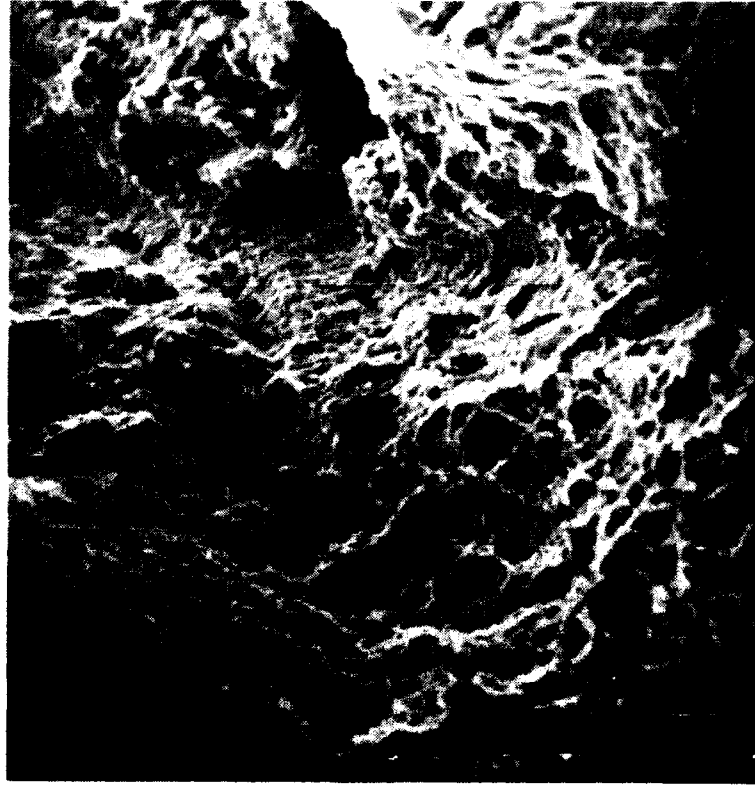
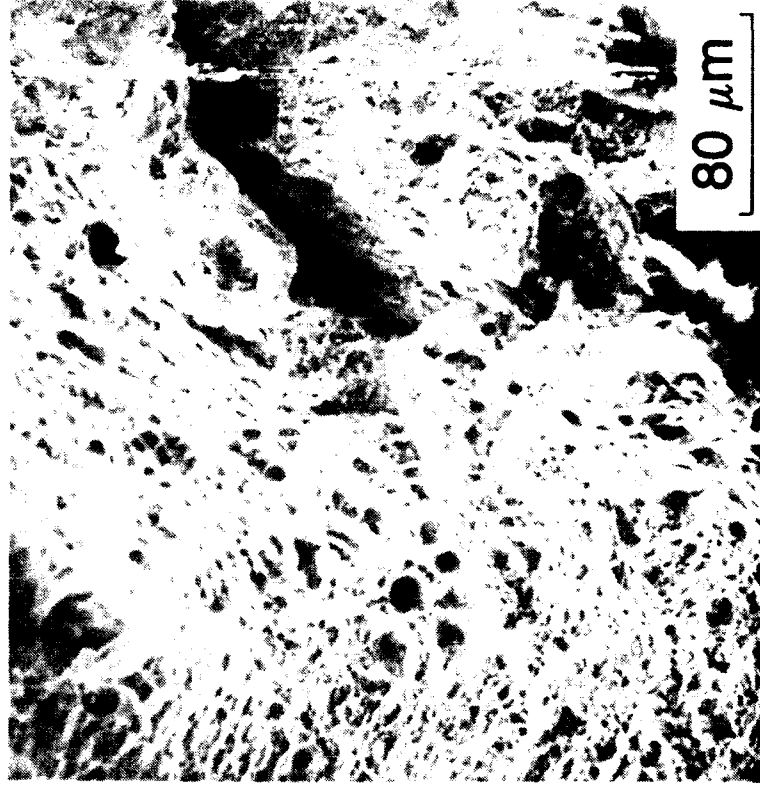
creep life of the MERL 72 was 1.3 hours compared with 289 hours for the DS-R80H. Similar reductions in the creep lives of the MERL 72 occurred at the lower stress levels. The appearance of the fracture surfaces of the MERL 72 creep-rupture specimens is shown in Figure 30. The micrographs show that the fracture surface exhibited microvoid coalescence which was consistent with the high level of ductility observed in the weld material. The results confirm that the weld material exhibited ductility levels consistent with the maintenance of the integrity of the blade/weld interface in the test specimens.

Figure 30. Scanning electron micrographs of the creep fracture surfaces of MERL 72.
